3. INTERMEDIATE FIELD TEST 1

3.1 TEST 1 OBJECTIVES AND TEST PIT OVERVIEW

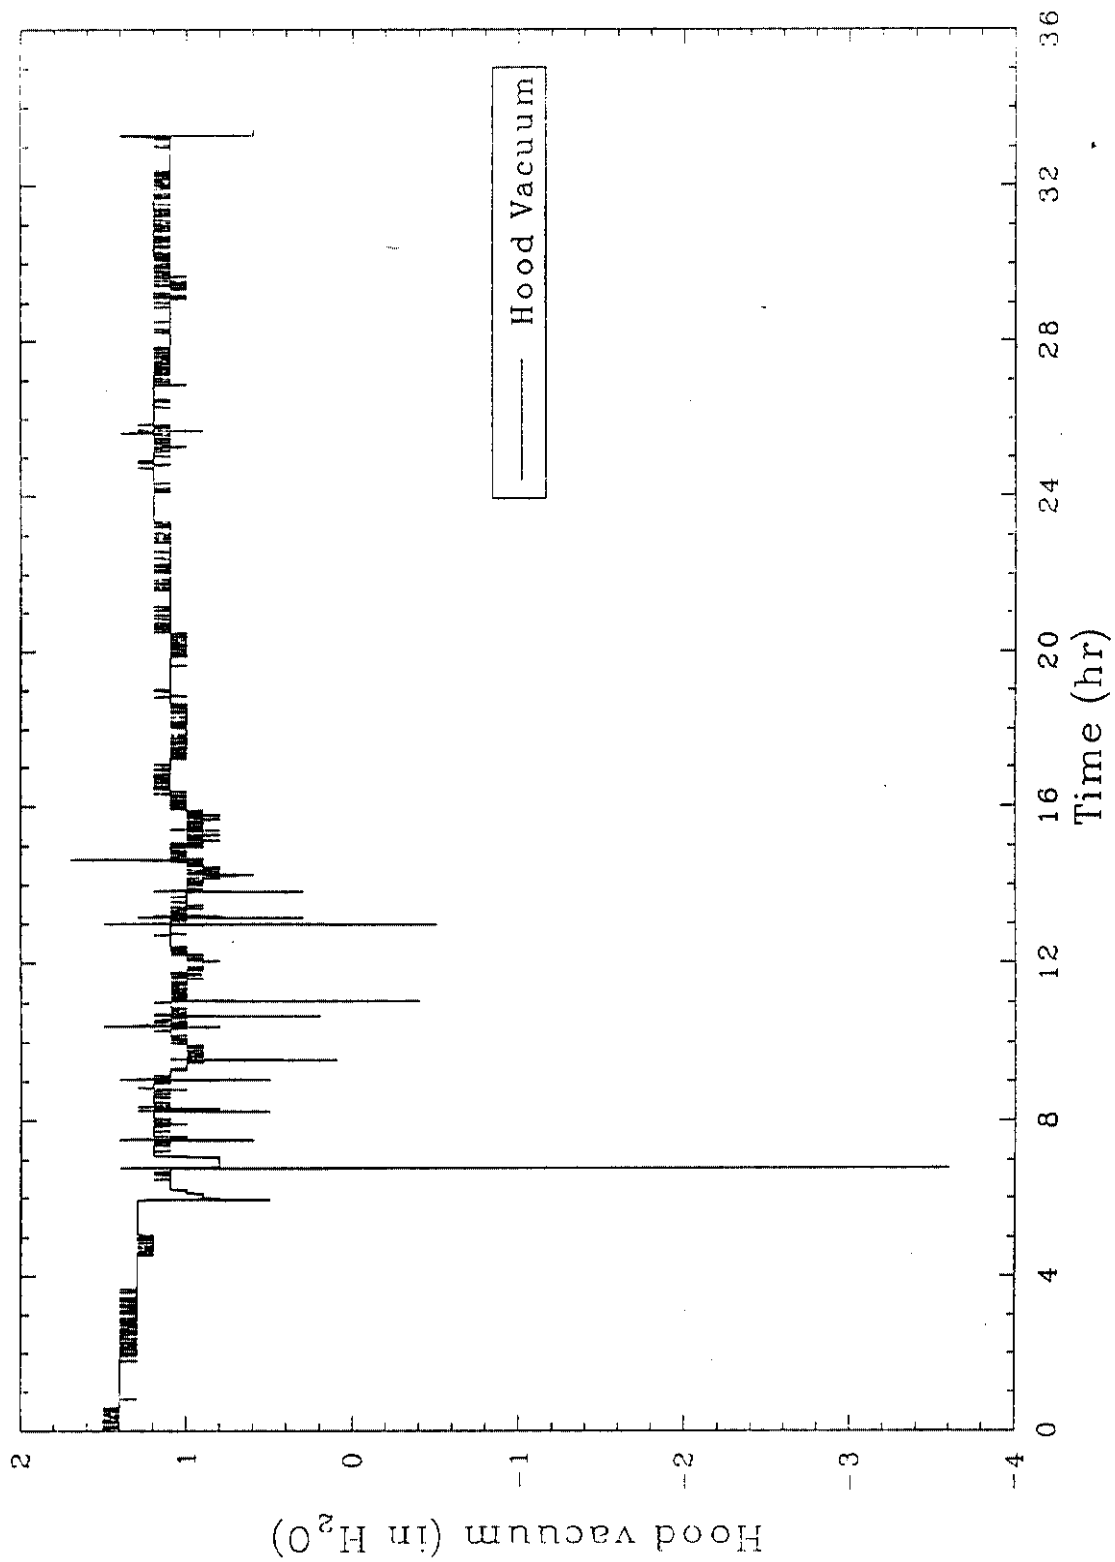
Figure 19. Hood vacuum plot showing pressure spikes for Test 1.

The intermediate-scale ISV system, appropriately sized for contaminated soil sites, was unable to contain transient pressure spikes in the containment hood on several occasions. This illustrates the need for a larger, more robust processing system for buried waste sites. These spikes were the result of relatively slow gas releases from containers, relatively slow gas generation created by the combustion of pyrolyzed products, and/or thermally induced expansions of existing gasses in the hood. The pressure spikes were not a sudden pressure spike characteristic of a detonation. Most pressure spikes occurred over a 10 to 30 second duration. In cases where the pressure in the hood did not exceed 1 in. of water, the gasses were contained within the surge volume in the hood and were subsequently drawn out to the process

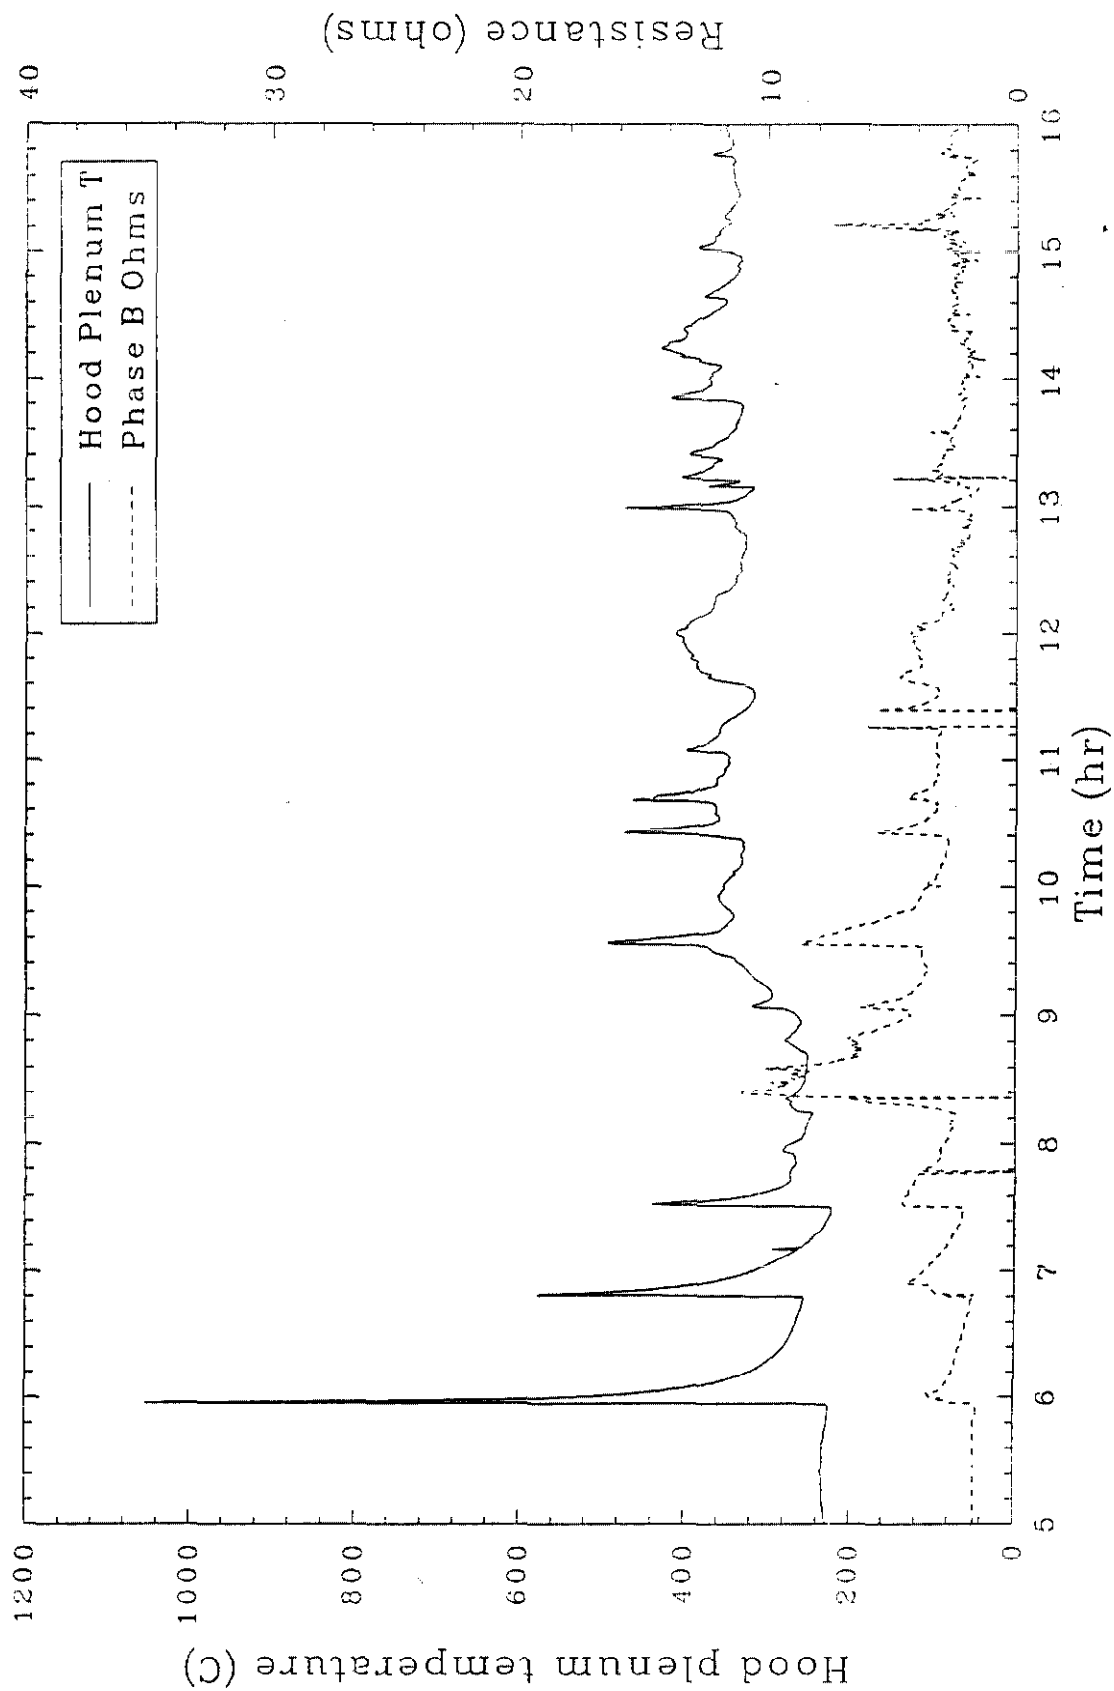
Figure 23. Hood plenum temperature and phase B resistance showing concurrent spiking in Test 1.

370 to 180 kW as a result of the event; this loss of power is illustrated in Figure 47. Radiant heat losses from the molten glass resulted in increased resistance in the molten glass as the glass cooled. This phenomenon occurred during essentially all gas releases (see Figure 23, p. 58).

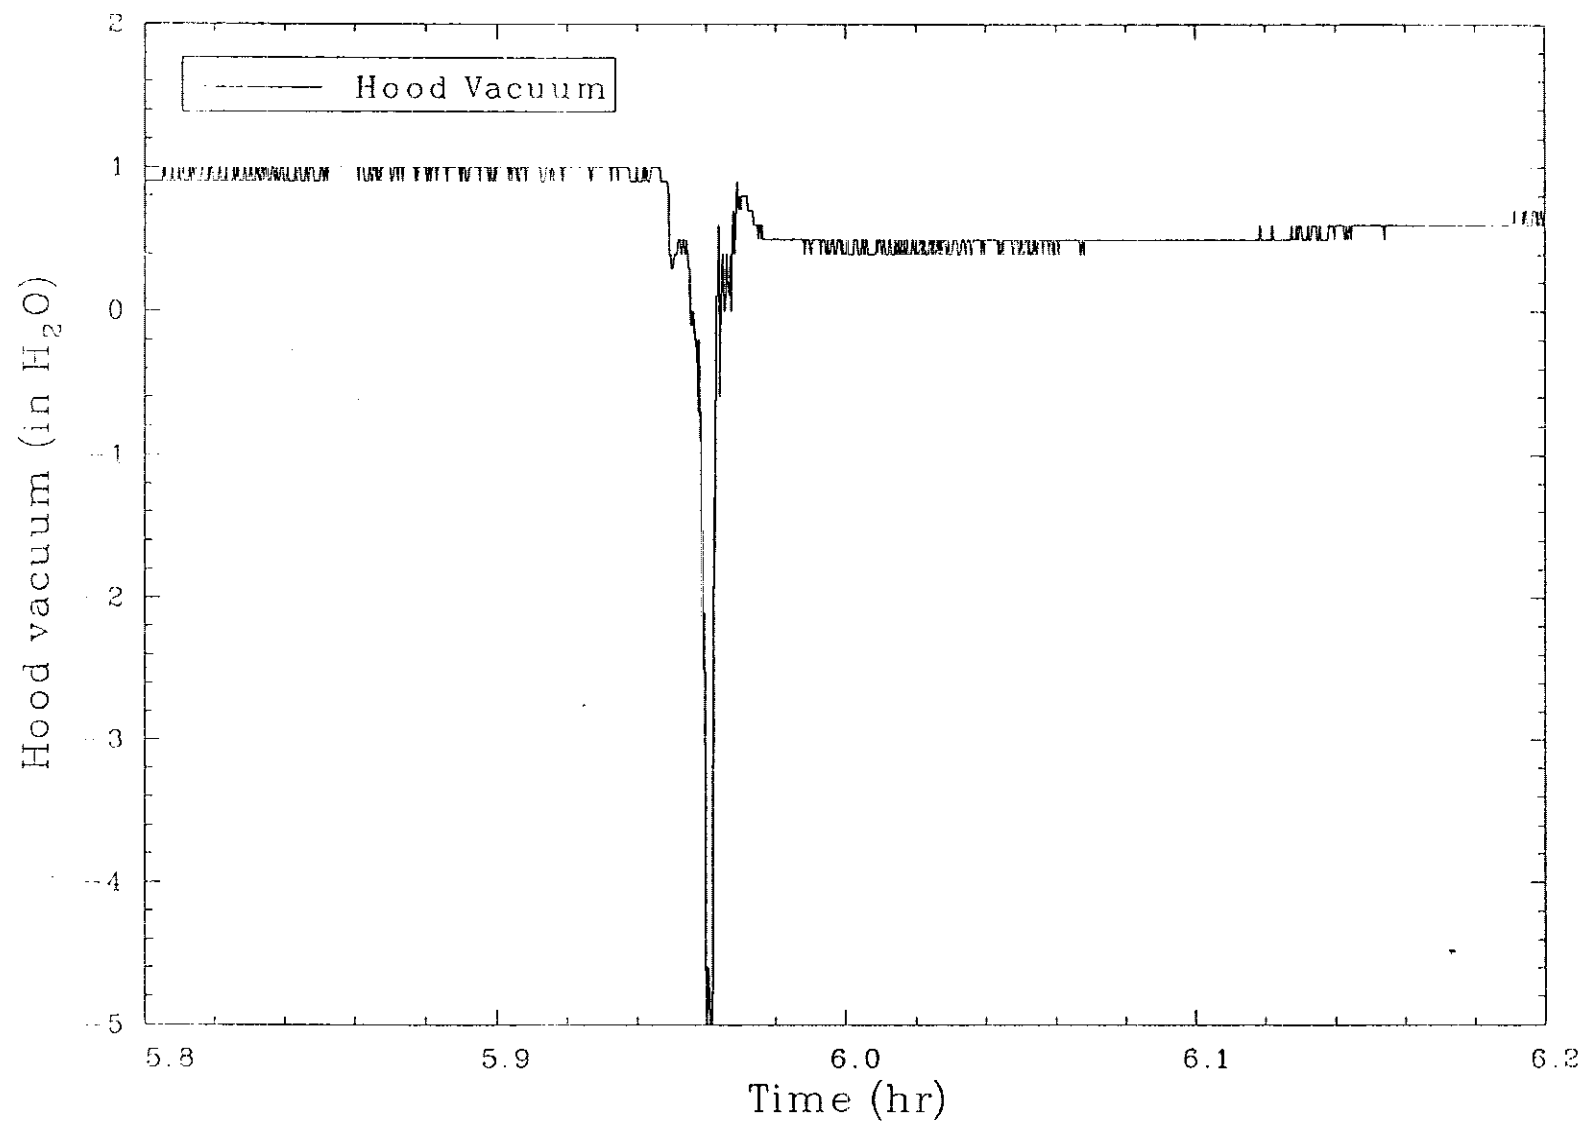
3.3.5.1 The Initial Event. The initial event occurred at approximately 5.9 hours into the test and resulted in the most dramatic temperature and pressure spikes for the test. In this event glass was ejected from the melt and contacted the hood surfaces at several locations including the tip of the plenum thermocouple. A hood vacuum plot of the event is provided as Figure 34. This event resulted in the most dramatic temperature spike (see Figure 23) even when accounting for glass contact on the plenum thermocouple. Figure 35 is a plot of roof and wall temperatures for several events and shows the dramatic temperature spike created by this initial event. The hood vacuum rapidly decreased during the event due to a rapid gas release from the melt, decreasing from an initial value of 0.9 in. of water to greater than 5.0 in. of water pressure. The pressure transducer range was from +5 to -5 in. of water; consequently, the exact magnitude of the pressure spike cannot be quantified. However, based on an estimate of the slopes when the data set is greatly expanded, the spike appears to have achieved a positive pressure of approximately 7 in. of water pressure.

Figure 34. Hood vacuum for the initial gas release event in Test 1.

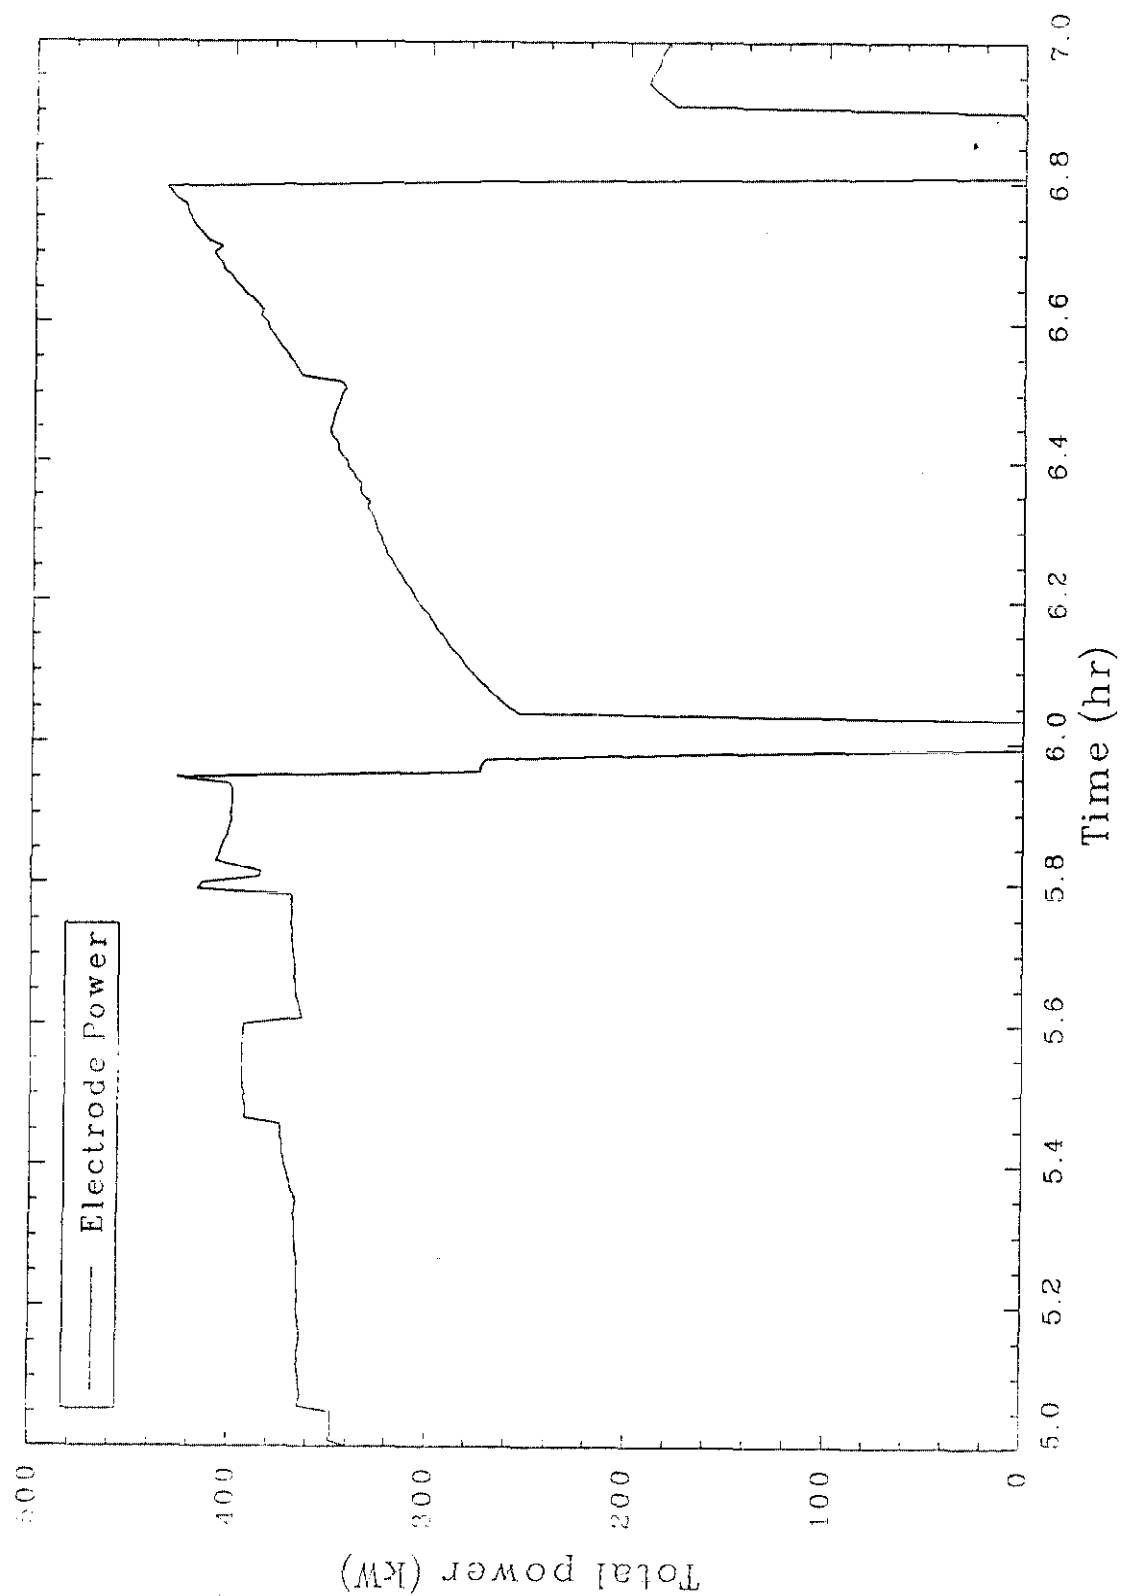
At the time of the event, operators responded by deenergizing electrode power. Once power was reenergized, power levels had decreased approximately 100 kW, as shown in Figure 36. Resistance in the melt, as calculated from measurements in the secondary windings of the transformer, increased from 2 to 20 ohms on phase A and from 2 to 4 ohms on phase B, as shown in Figure 37. This difference in resistance on the secondary windings suggests the event had a localized effect adjacent to a phase A electrode. Resistance data both during startup and at later times in the test show the phases A and B resistance values agreed closely, as expected. Therefore, there is confidence in the resistance measurements indicating a localized effect on a phase A electrode. Resistance gradually returned to pre-event levels, approximately

Figure 36. Total electrode power for Test 1, showing power level decrease after the initial event.

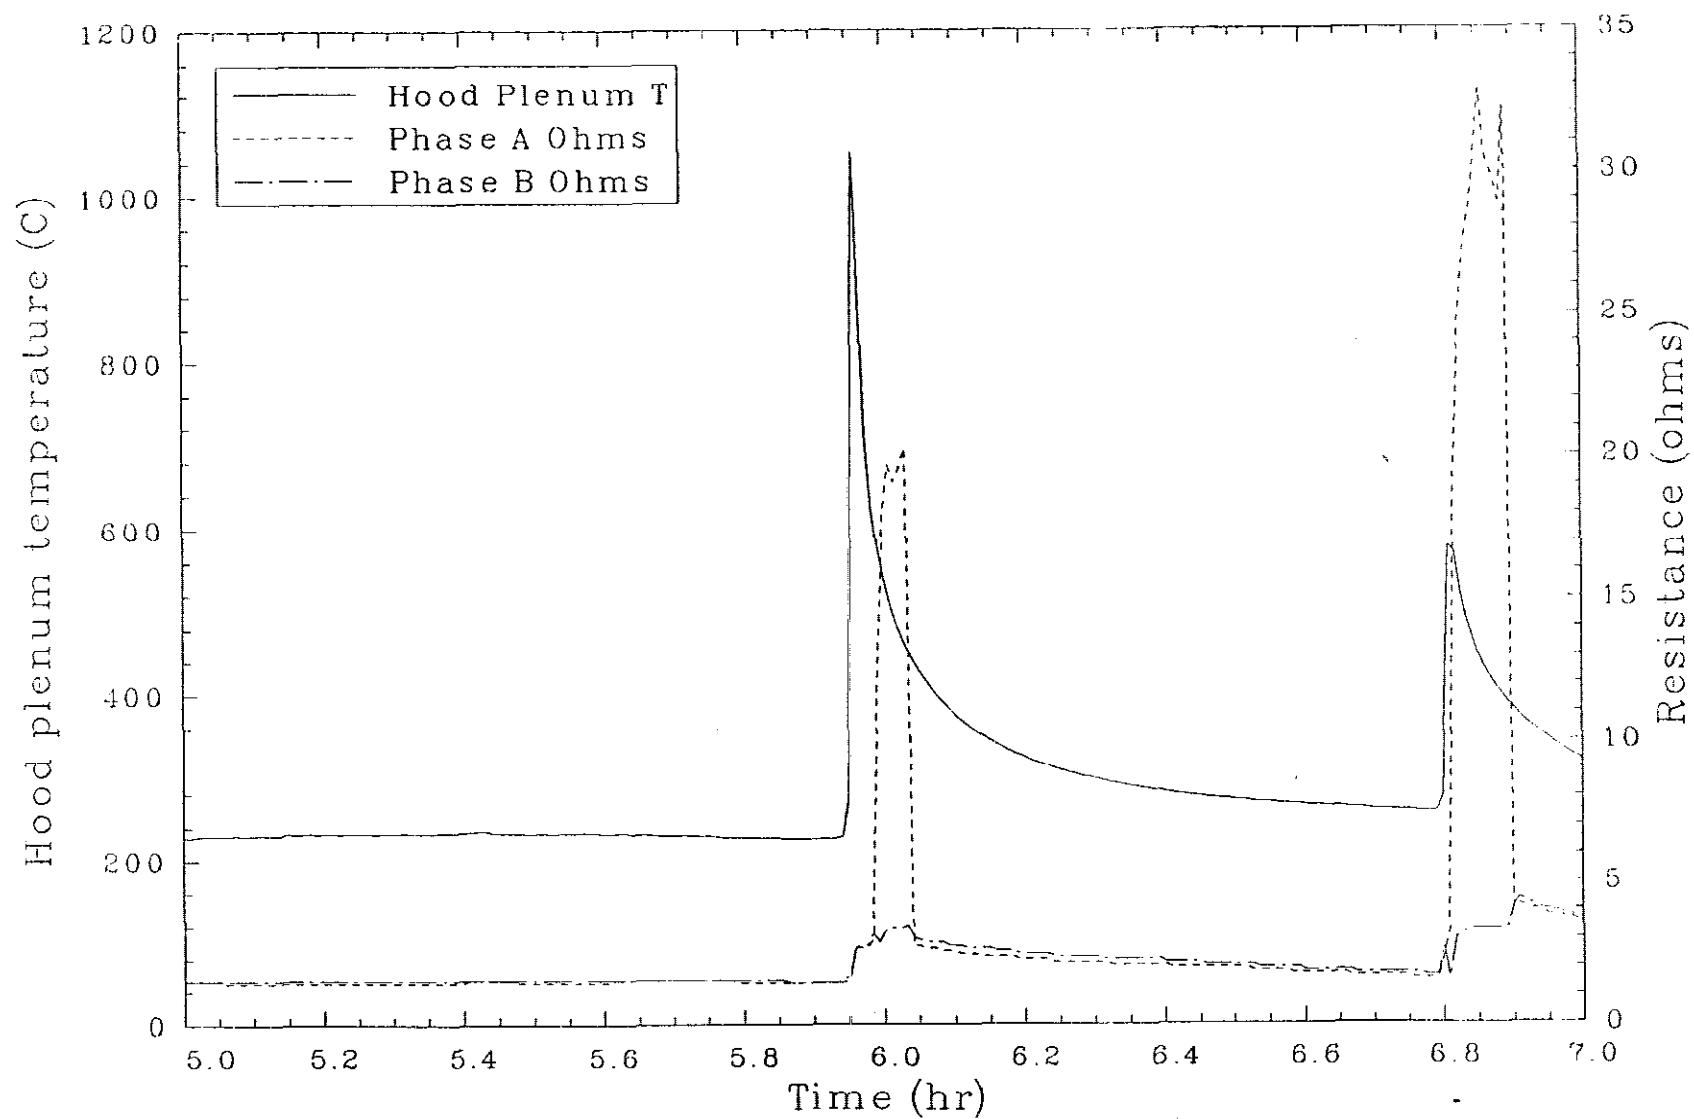
Figure 37. Phase A and B resistance during the initial gas release event in Test 1.

- A gas release caused a localized cooling effect on the glass. Any gas release through molten glass would act to remove heat from the glass and disrupt the cold cap, creating a situation where the molten glass could lose heat radiantly. Due to convective mixing currents in the melt, a localized area of cooled glass could be mixed, and increased resistance would be observed on both phases. As shown in Figure 37, resistance on phase B increased from 2 to 4 ohms.

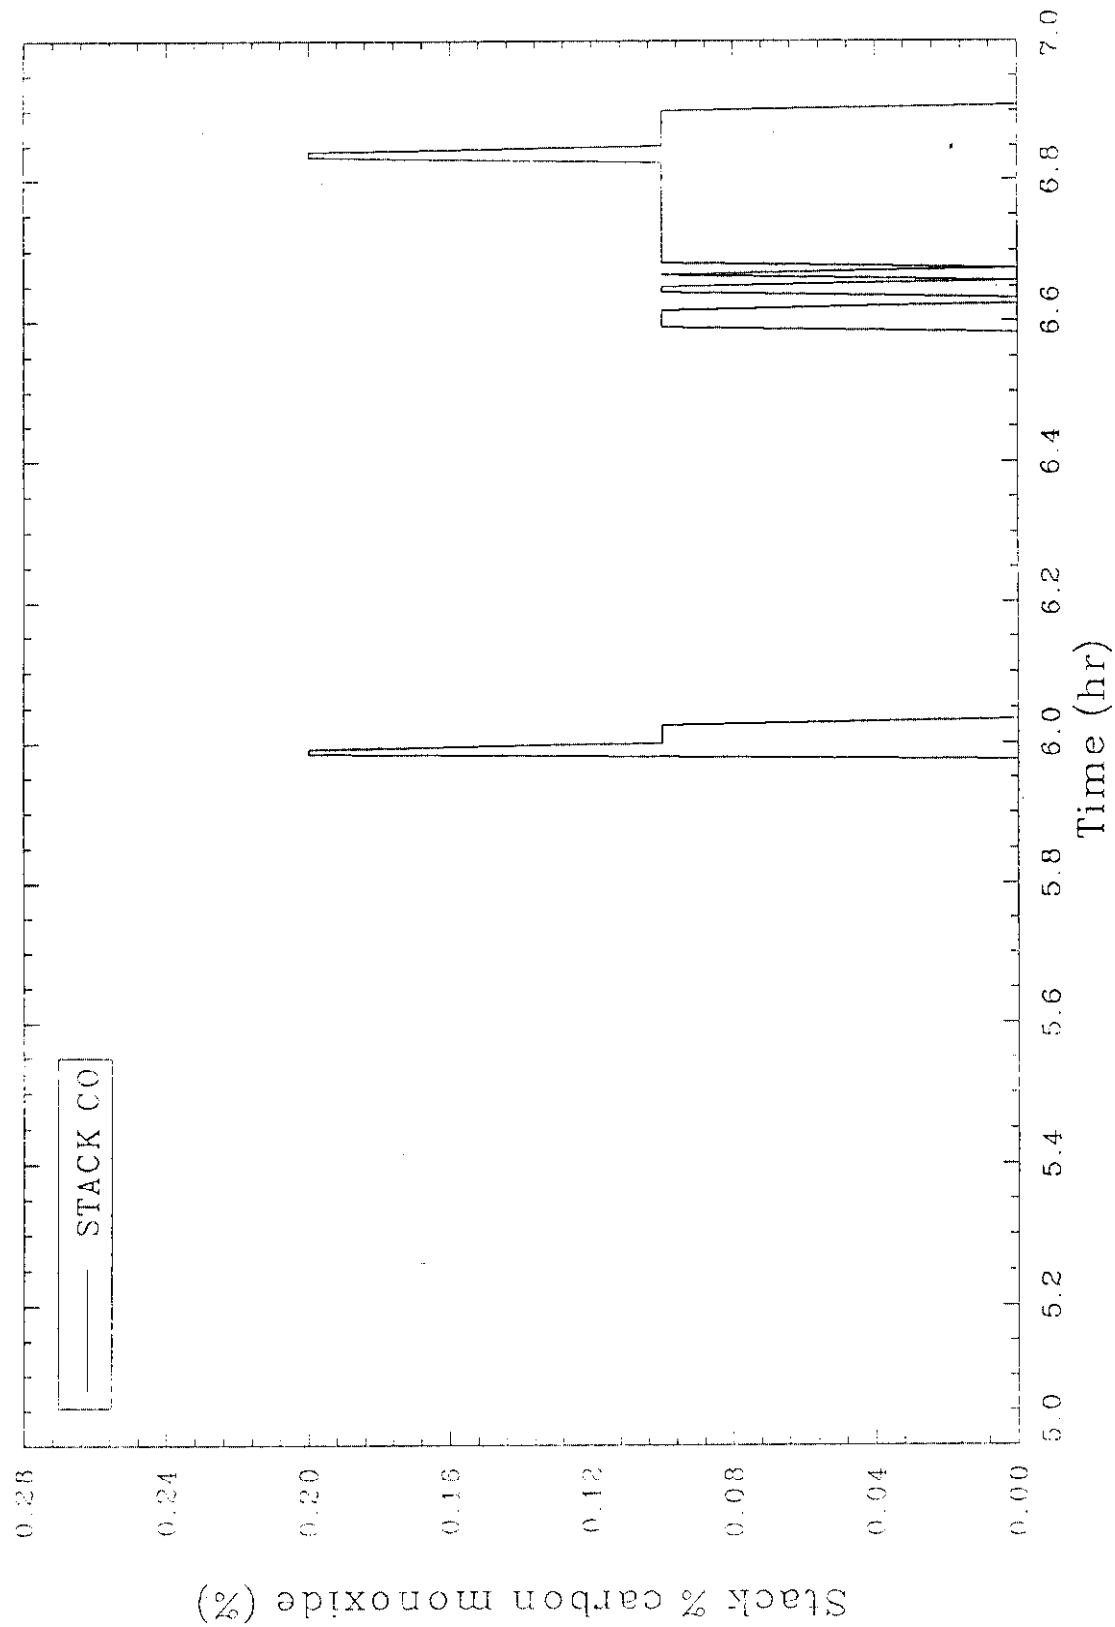
Carbon monoxide concentrations indicate that a significant volume of combustible gasses burned in the hood during the transient event. Carbon monoxide values at the stack spiked from 0 to 0.2% and then returned to 0%, as

shown in Figure 38. Oxygen concentrations dropped to just under 12%, which was the lowest level observed during the test.

Figure 38. Stack carbon monoxide concentration during the initial gas release event in Test 1.

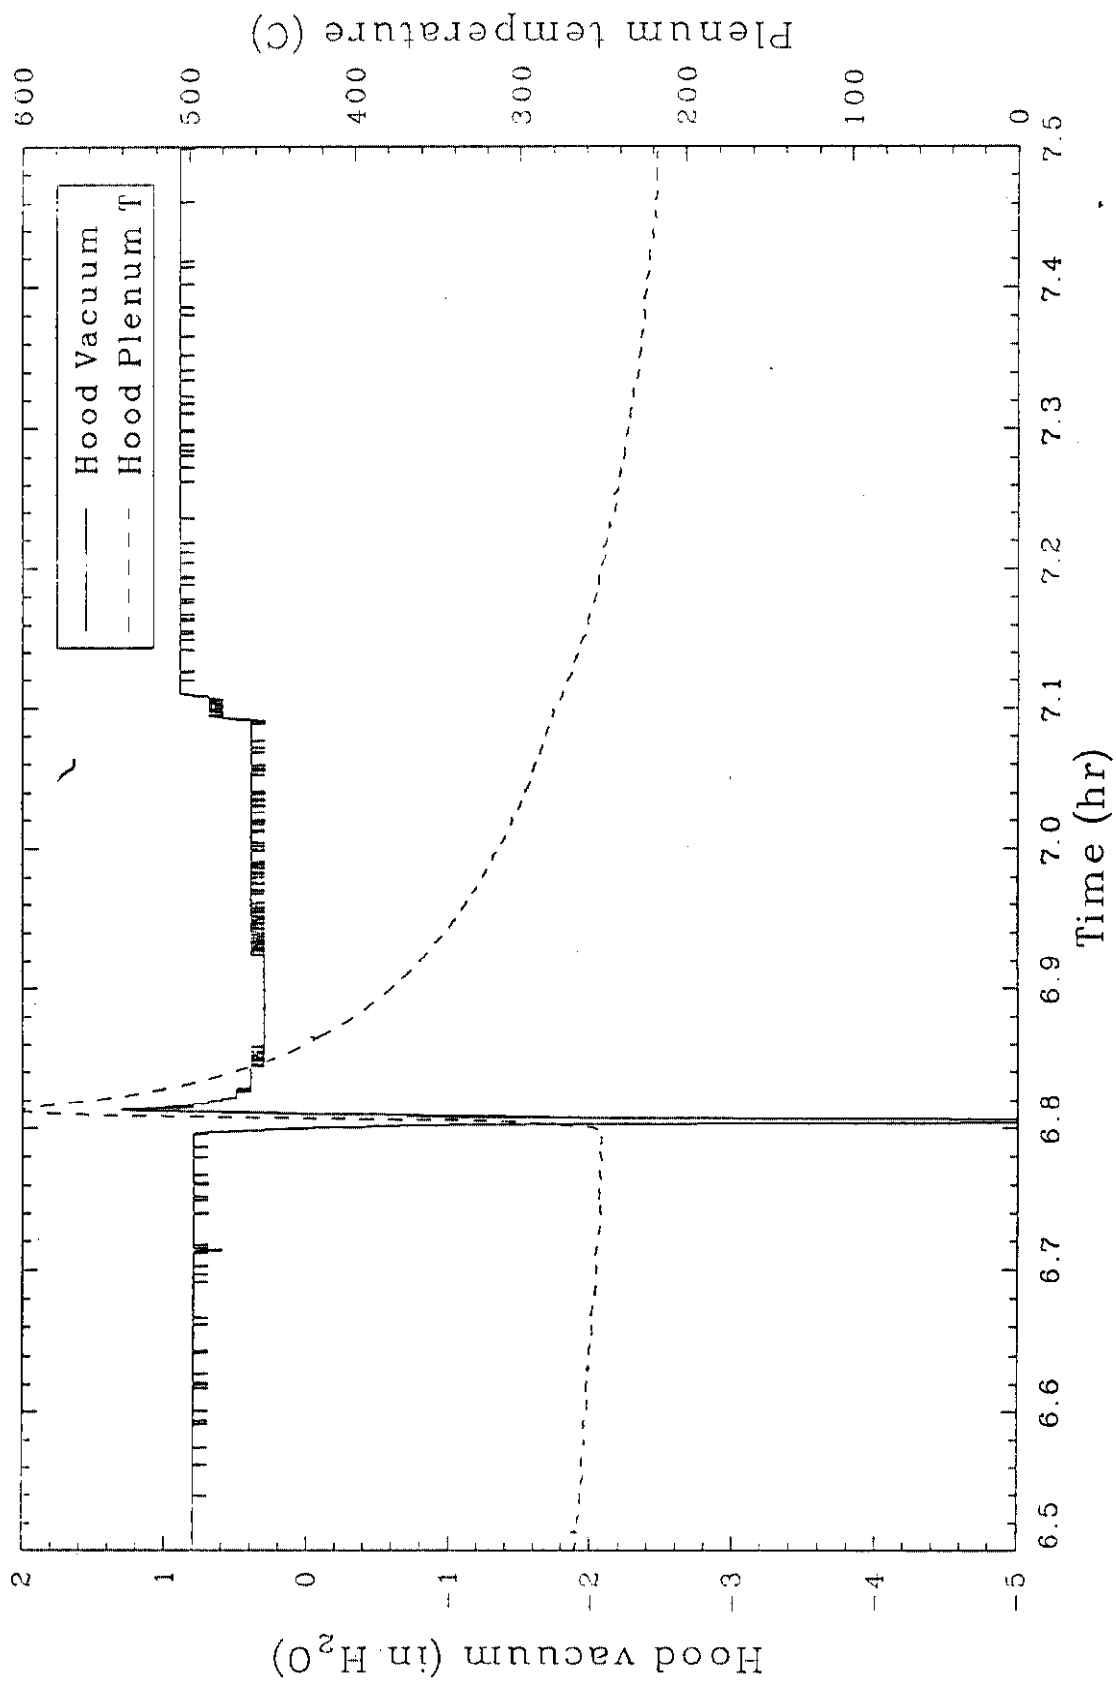
3.3.5.2 The Second Event. A second event occurred at approximately 6.8 hours into the test. This event resulted in the a dramatic hood pressurization similar to the initial event. Hood pressure spiked from 0.9 in. of water vacuum to over 5.0 in. of water pressure, as shown in Figure 39. The pressurization was followed by a temperature spike from 260 to 600°C.

Figure 39. Hood vacuum and plenum temperature during the second event in Test 1.

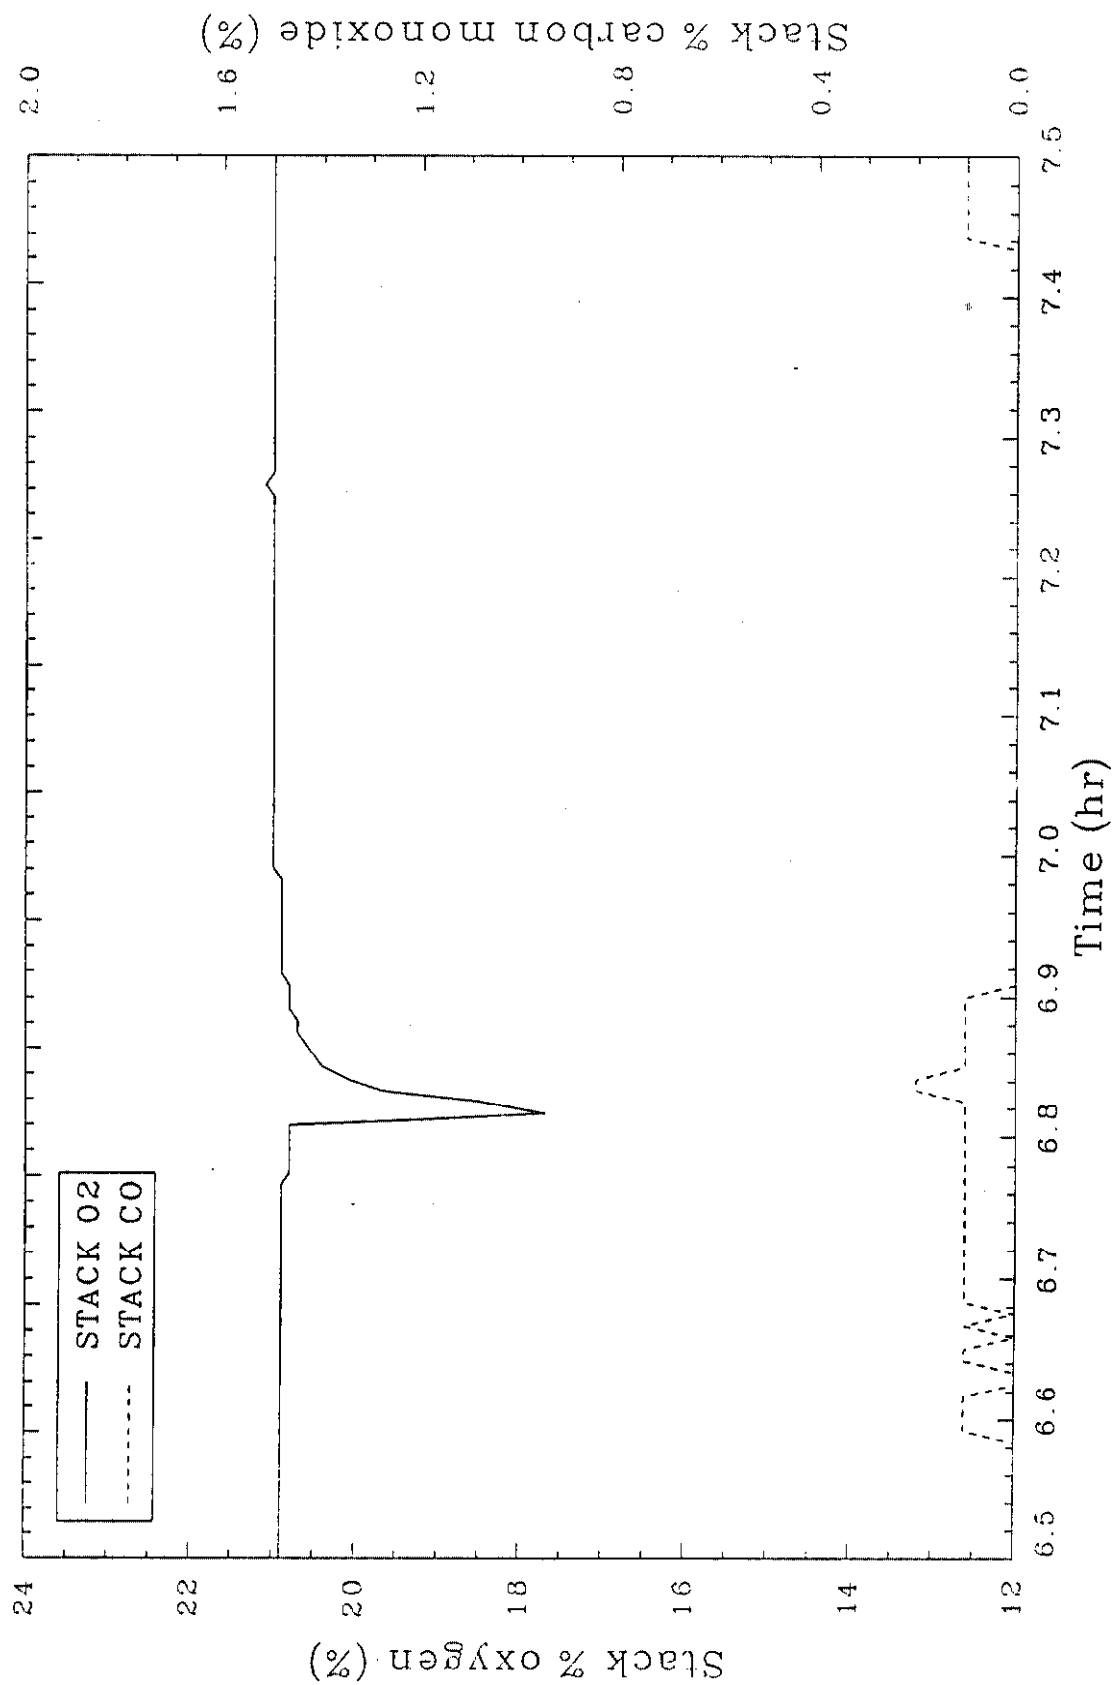
Operators observed smoke escaping from the hood around the base of the hood and out through the HEPA filtered seal pot. Soil providing a seal at the base of the hood by the door was dislodged as pressure was relieved from the hood. Carbon monoxide concentrations at the stack increased from 0.1 to 0.2%, and oxygen concentration dropped from approximately 20.5 down to 17.5%, indicating that significant combustion occurred in the hood, shown in Figure 40.

Figure 40. Stack oxygen and carbon monoxide concentrations during the second event in Test 1.

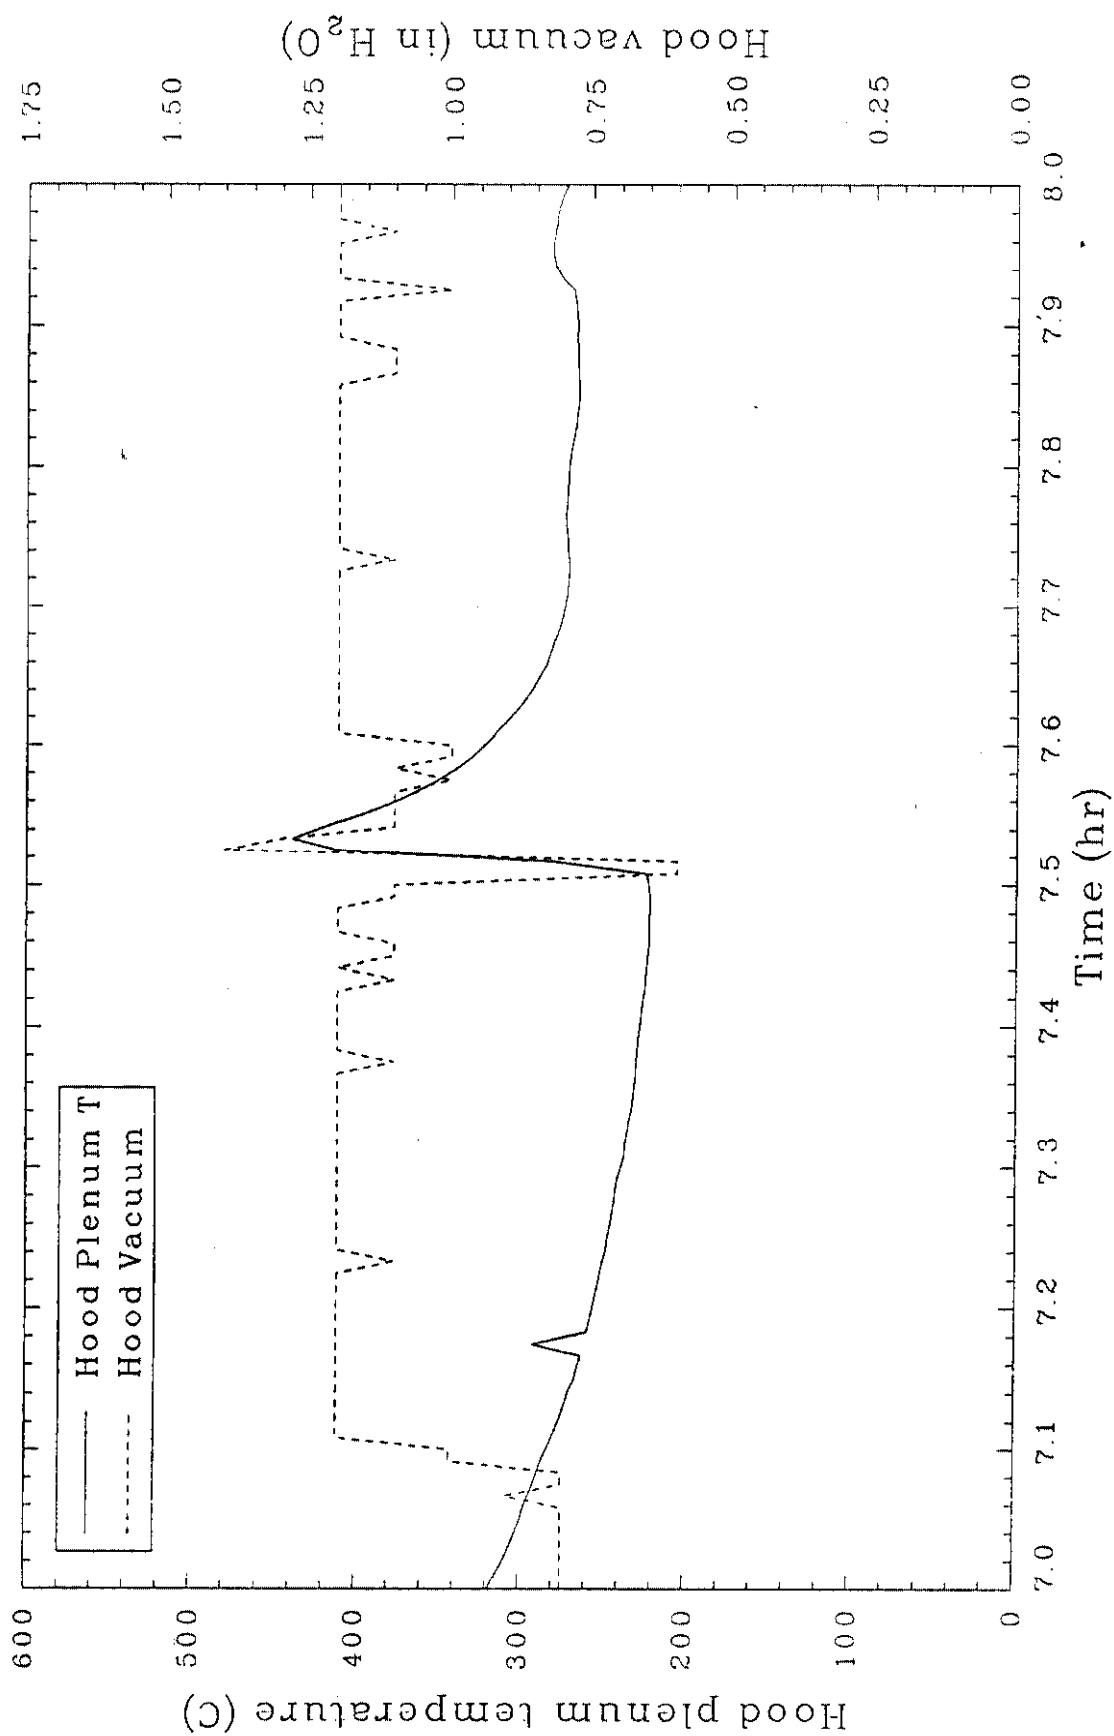
3.3.5.3 The Third Event. The third event occurred at approximately 7.5 hours and resulted in only moderate plenum temperature and hood vacuum spikes relative to the first two events. The plenum temperature increased from approximately 220 to just over 440°C. The hood vacuum spiked from 1.2 to 0.6 in. of water. Figure 44 shows the temperature and vacuum relationship for this third event.

Figure 44. Hood vacuum and plenum temperature for the third event in Test 1.

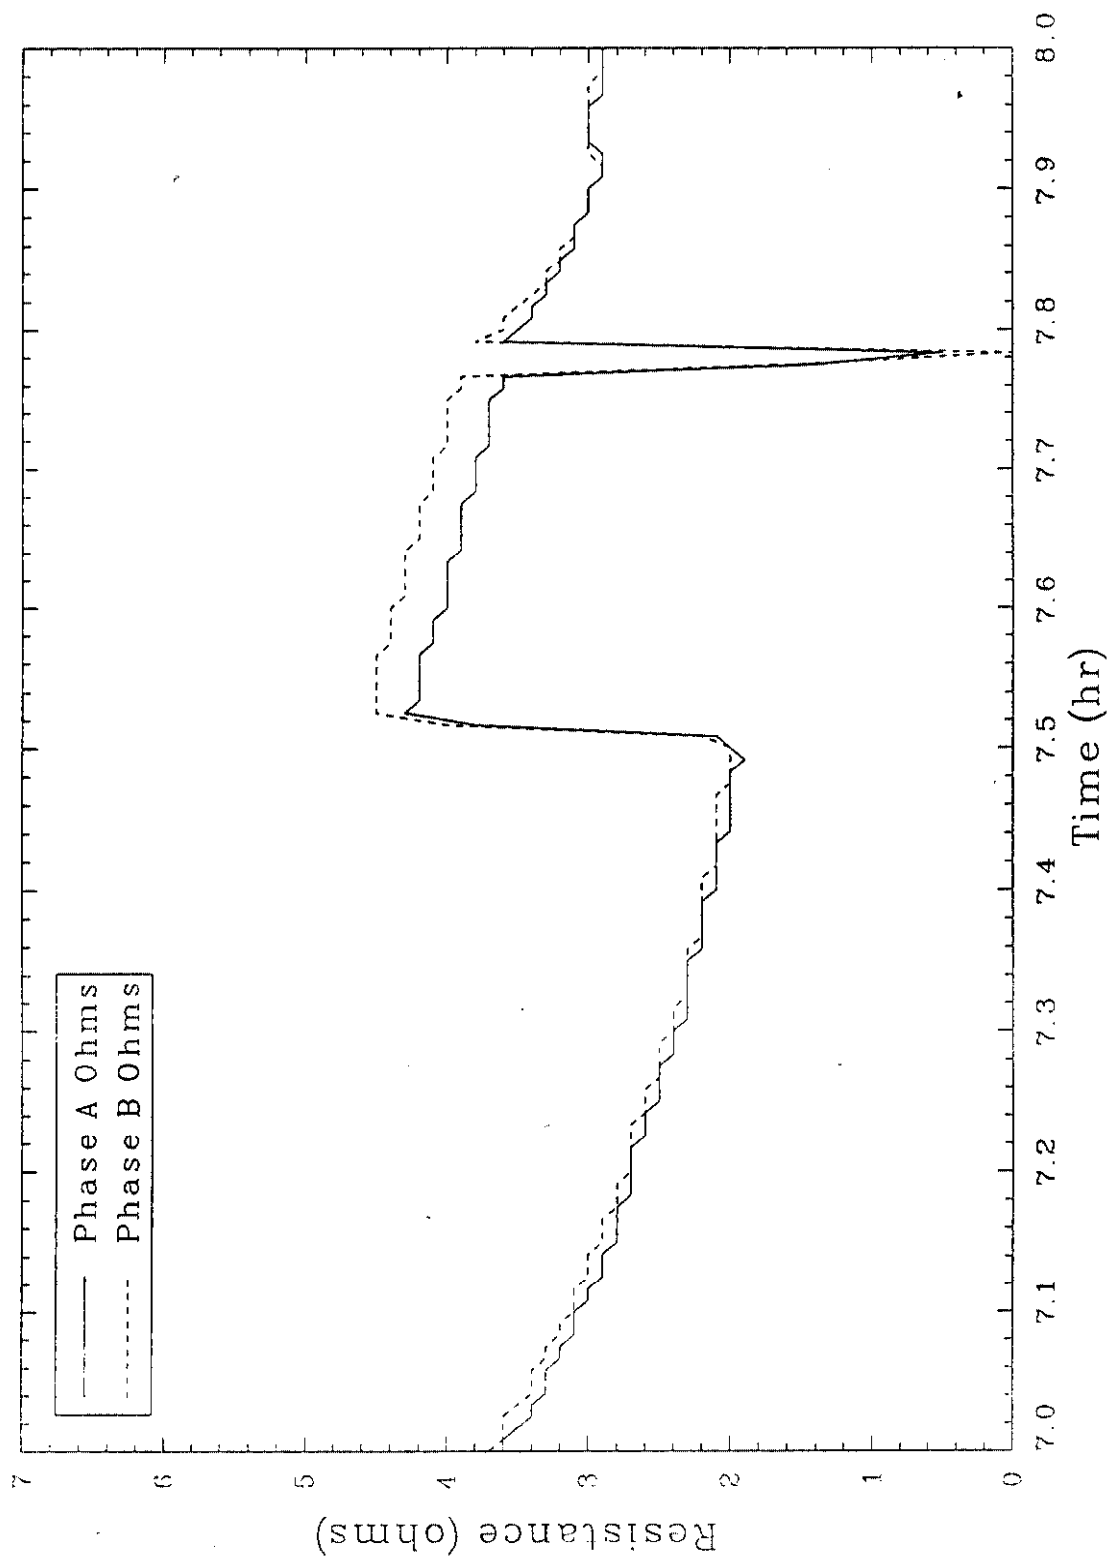
Electrical resistance data was balanced, unlike the previous two events. Phases A and B increased from 2 ohms to just over 4 ohms as a result of the event, shown in Figure 45. Power was not interrupted by operators during the event. Phase A amperage dropped from 320 to 160 A; and phase B amperage dropped from 300 to 140 A, as shown in Figure 46. Total power dropped from

Figure 45. Phases A and B resistance for the third even in Test 1.

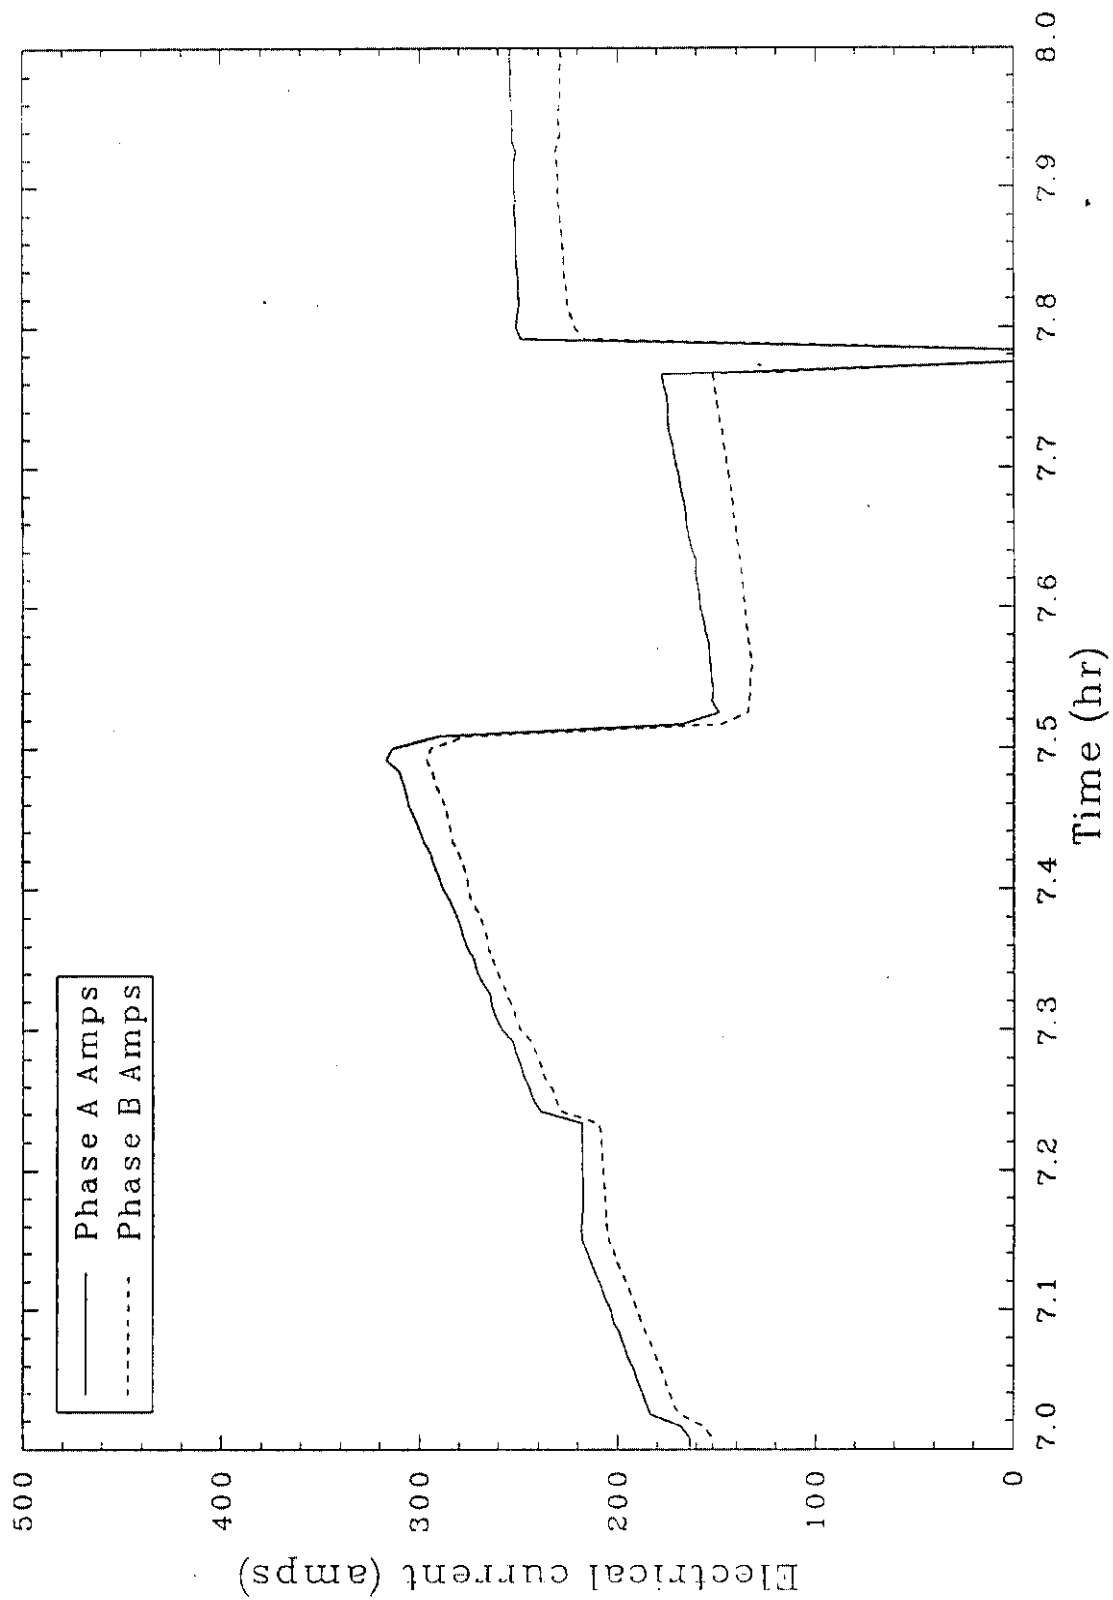
Figure 46. Phase A and B amperage for the third event in Test 1.
